News Trends in Selection of Metallic Material for Desalination Industry

Authors: *Jérôme Peultier, Véronique Baudu, Pauline Boillot, Jean-Christophe Gagnepain*

REF: IDAWC/DB09-195

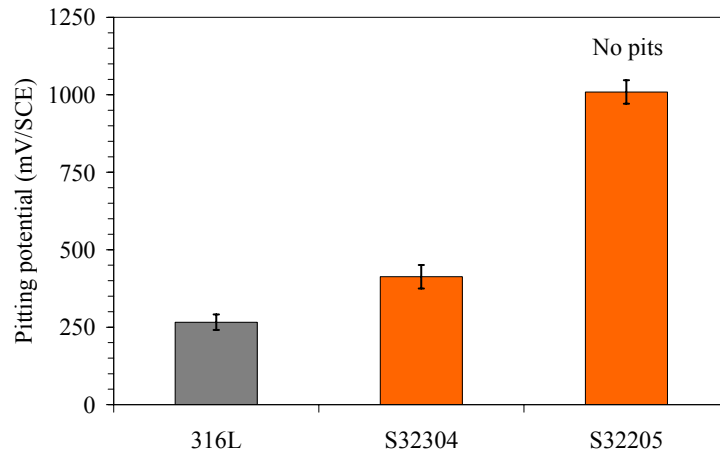
Figure 4: pitting potential in 50g/L NaCl solution at pH=6.4 and 50°C.

The measurement of the pitting potential in synthetic brine (NaCl 50g/L, pH 6.4 and 50°C / 122°F) provides a good idea of the pitting corrosion resistance. The higher the pitting potential, the greater the pitting corrosion resistance. Figure 4 indicates that pits are observed for both the 316L austenitic grade and for UNS S32304 but a slightly higher pitting potential for the duplex grade. On the contrary, grade UNS S32205 does not exhibit a pitting potential because no pits are developed and the measured potential corresponds to the oxidation of the water. We can expect, therefore, that the pitting corrosion resistance for austenitic grades will be slightly lower than for UNS S32304 and significantly lower than UNS S32205. Figure 5 presents the values measured in a synthetic solution with slightly lower chloride content (30g/L instead of 50 g/L NaCl). Nevertheless at 50°C, the pitting potentials of the UNS S2304 and 316L are rather similar (see Figure 4 and Figure 5). For lower temperatures, the difference between the two grades increases in favour of the duplex stainless steel grade. For temperatures higher than 50°C, similar low values are reported. These results obtained with UNS S32304 show that 23% chromium in a duplex microstructure is at least as beneficial for pitting corrosion resistance as 17% chromium and 2% molybdenum in an austenitic microstructure. In addition to the high chromium content, a molybdenum addition significantly increases the corrosion resistance of duplex family (see UNS S32205 in Figure 4).

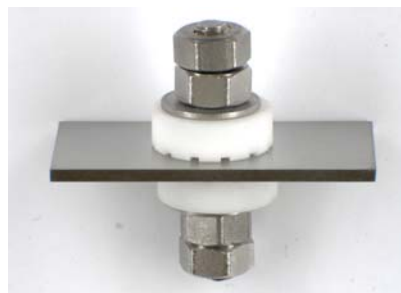
Figure 7: photography of a multi crevice assembly (MCA).

3.1.2 Crevice corrosion resistance - Specimens were immersed in stirred synthetic brine solution containing 50g/L NaCl, at pH=6.4 and 50°C. A multi crevice assembly (MCA) (see Figure 7) was used to simulate a crevice configuration on the sample surface. It consists of two TFE-fluorocarbon segmented washers (see Figure 6), each having a number of grooves and plateaus (see Table 2). A TFE-fluorocarbon tubular sleeve (for electrical isolation), and a bolt, a nut, and flat washers of UNS N10276 have been used to fasten the crevice washers to the specimen. A torque of 1.6 Nm was applied on the bolt.

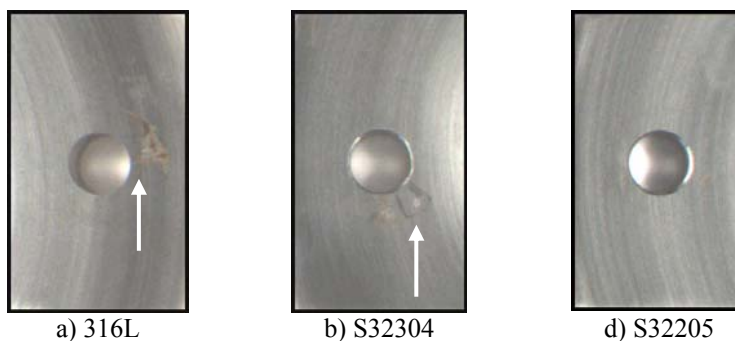
Figure 9: pictures of coupon surfaces after the immersion test in 50g/L NaCl solution at pH 6.4 and 50°C (white arrows indicate crevice attacks).

The observations (see Figure 9 and Table 3) reveal one crevice on each sample of the 316L and UNS S32304. For 316L the maximum depth and weight loss are a little bit higher than for UNS S32304. These results are in good agreement with the recorded values of the corrosion potentials. For UNS S32205, no crevice attack is observed after the completion of the test.

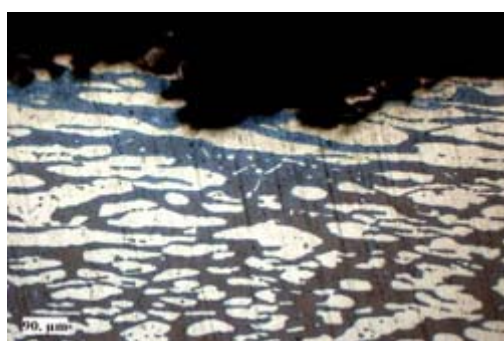
Figure 10: picture of a UNS S32304 cross section sample in the crevice corroded area under the MCA after 1000h immersion in 50g/L NaCl solution at pH 6.4 and 50°C (NaOH etching).

Figure 10 shows a preferential dissolution of the ferrite phase for the duplex grade. The ferrite phase, which contains less Nickel, than the austenite is probably less resistant to uniform corrosion in the reducing acidic conditions developed in crevice area.

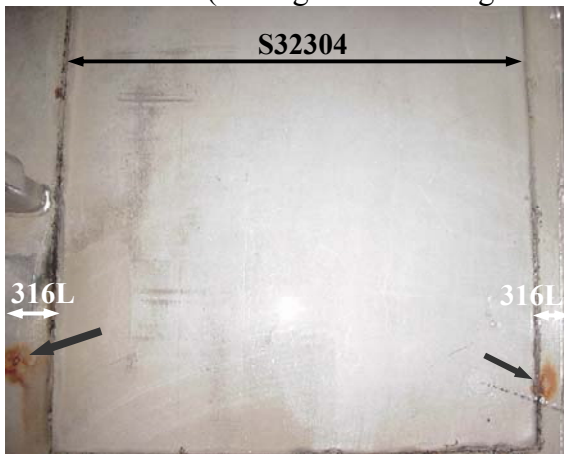
Figure 11: photograph of UNS S32304 welded onto 316L surface (arrows shows pitting attack)

3.2.1 Saint Barthelemy Site - Two UNS S32304 plates of 600 × 600mm were welded in the bottom of both a hot and a cold 316L evaporator cell. This desalination plant was in operation almost continuously during the 2 years of exposure, from December 2001 to November 2003. The field test conditions are representative of a well-controlled evaporator, with a practically continuous operation. Figure 11 shows the surface of the UNS S32304 welded onto 316L parts in two different cells. No corrosion attacks were observed on the two UNS S32304 plates. The duplex grade seems to have at least a similar pitting resistance behavior compared to the 316L. In fact, only two pits were observed and those were on the 316L near the weld (see Figure 11 and Figure 12).

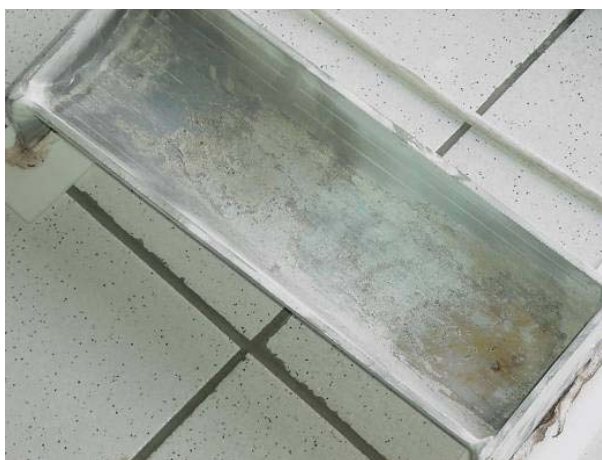
Figure 14: photograph of UNS S32304 sample after exposure in cell n°1

According to SIDEM, this field test appears to be very aggressive due to the long and repeated operational shutdown periods. The UNS S32304 is in contact with either the deaerated brine or the aerated brine for approximately equal periods. Figure 14 shows the sample after the exposure in cell n°1 with lots of saline deposits and only one corrosion attack observed on the whole surface. For the sample exposed in cell n°12, no corrosion products are observed on the surface. These observations were confirmed after cleaning. The sample exposed in cell n°1 shows only one corrosion site of 4mm diameter (see Figure 15) and no corrosion is observed on sample exposed in cell n°12 (see Figure 16). Based on the experience of the desalination plant designer, the behavior of UNS S32304 is at least as good as that of 316L.

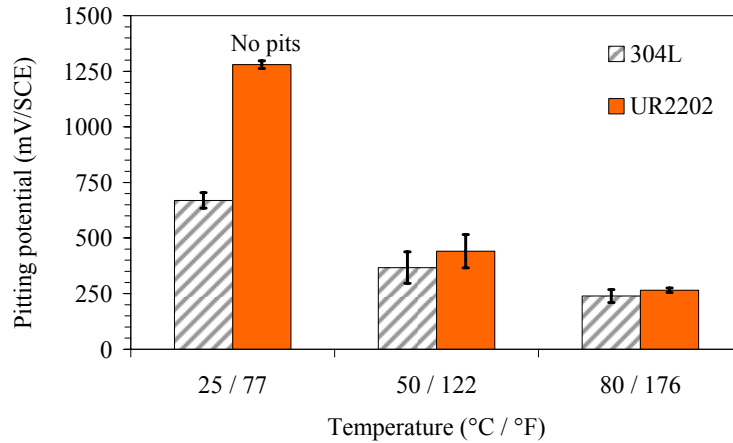
Figure 18: pitting potential in 1000ppm chloride containing solution at pH 4.5.

When pH loses one unit and chloride concentration increases up to 1000ppm, the pitting potential of 304L decreases to 670mV/SCE whereas UNS S32202 is still not prone to pitting (see Figure 18). At 50°C and then 80°C, the pitting potential measured on the duplex grade is slightly higher than that of the 304L.

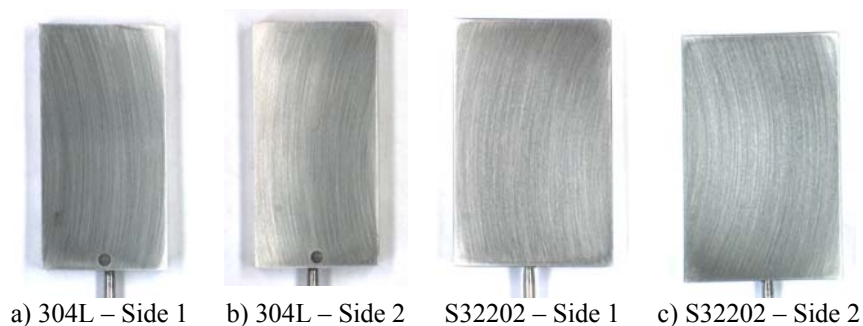
Figure 21: pictures of surfaces after the immersion test in 1000ppm chloride ion solution at pH 4.5 and 25°C.

The corrosion potentials of the two stainless steels increase quickly during the first 4 days then reach a relatively stable value around 100 – 120mV/SCE. A limited number of potential instabilities were observed during the one month immersion showing that the passive layer built in this environment is relatively stable. After one month, no pits were observed and the calculated uniform corrosion rate is lower than 0.5µm/y (see Figure 21).
